R22 & R44 SAFETY ALERT

Issued: 23 February 2018

A016-4, C016-2, & C016-5 MAIN ROTOR BLADES

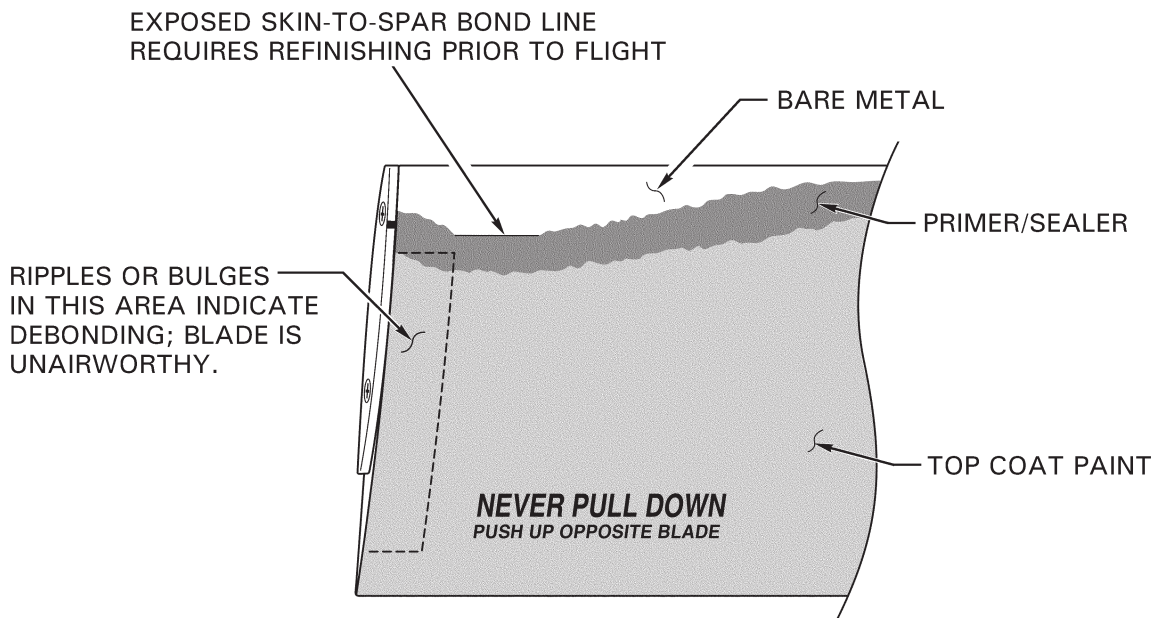
MAIN ROTOR BLADE LOWER SURFACE

RHC has received additional reports of improper inspection or poor maintenance resulting in skin debonding on earlier-design main rotor blades with stainless steel skins. Debonding can occur when the bond line at the spar is exposed due to erosion of the blade finish, or when corrosion occurs on the internal aluminum tip cap. R22 Service Bulletin SB-103A and R44 Service Bulletin SB-72A require the blades to be inspected by a mechanic at least every four months. FAA AD 2014-23-16 requires the pilot, before the first flight of each day, to visually check for any exposed (bare metal) skin-to-spar joint area on the lower surface of each blade. Pilots should also check for ripples or bulges on the outboard end of the blade skin, which would indicate corrosion damage and debonding between the skin and tip cap (see figure below). Failure to inspect and maintain the blades properly, particularly in harsh or corrosive environments, can allow erosion or corrosion to develop to the point that skin debonding occurs, potentially leading to a fatal accident. Do not fly with damaged blades!

AD 2014-23-16 also requires that all A016-4, C016-2, and C016-5 main rotor blades be taken out of service by 9 January 2020. RHC will offer a special discounted price for A016-6 and C016-7 blades to operators who choose to replace their blades earlier. Contact RHC Customer Support for additional information.
